Project No.: VT-25400-01

Project: Oxnard High School Pool Repairs
3400 West Gonzales Road
Oxnard, California

Subject: Potential Effects of Groundwater During Pool Repair Operations

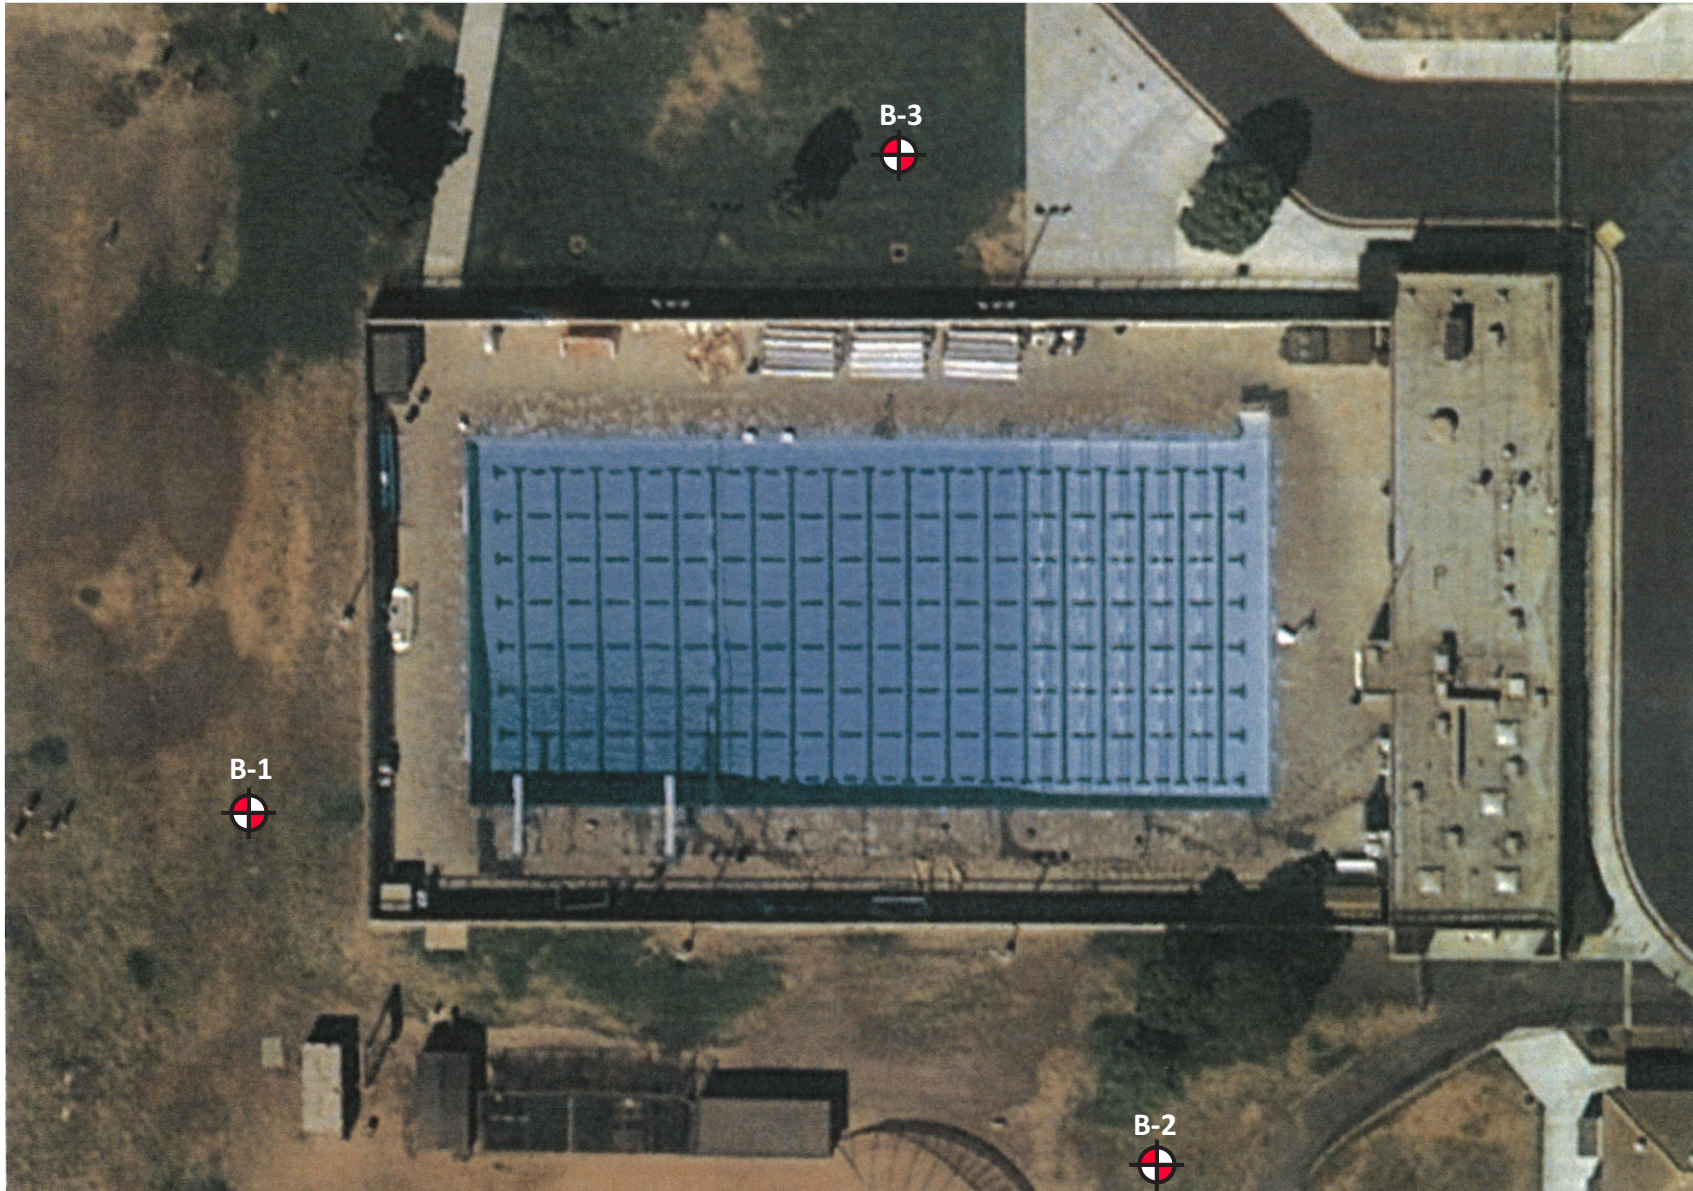
SITE PLAN

On August 14, 2017, three borings were advanced to the south, west, and north of the existing facility to measure current depths to groundwater. The relative elevations of the three borings varied, but when standardized using a manometer device accurate to hundredths of a foot. Groundwater elevations were measured using an electronic device that had equal accuracy. Measured groundwater depths ranged from 25.77 to 26.40 feet below the existing pool deck surface.

Approximate Boring Location
