August 13, 2019

Subject: Asbestos & Lead Roofing Survey
Channel Islands High School – Buildings B & C
1400 Raiders Way
Oxnard, CA 93033
FCG Job Code: OUHSD-35

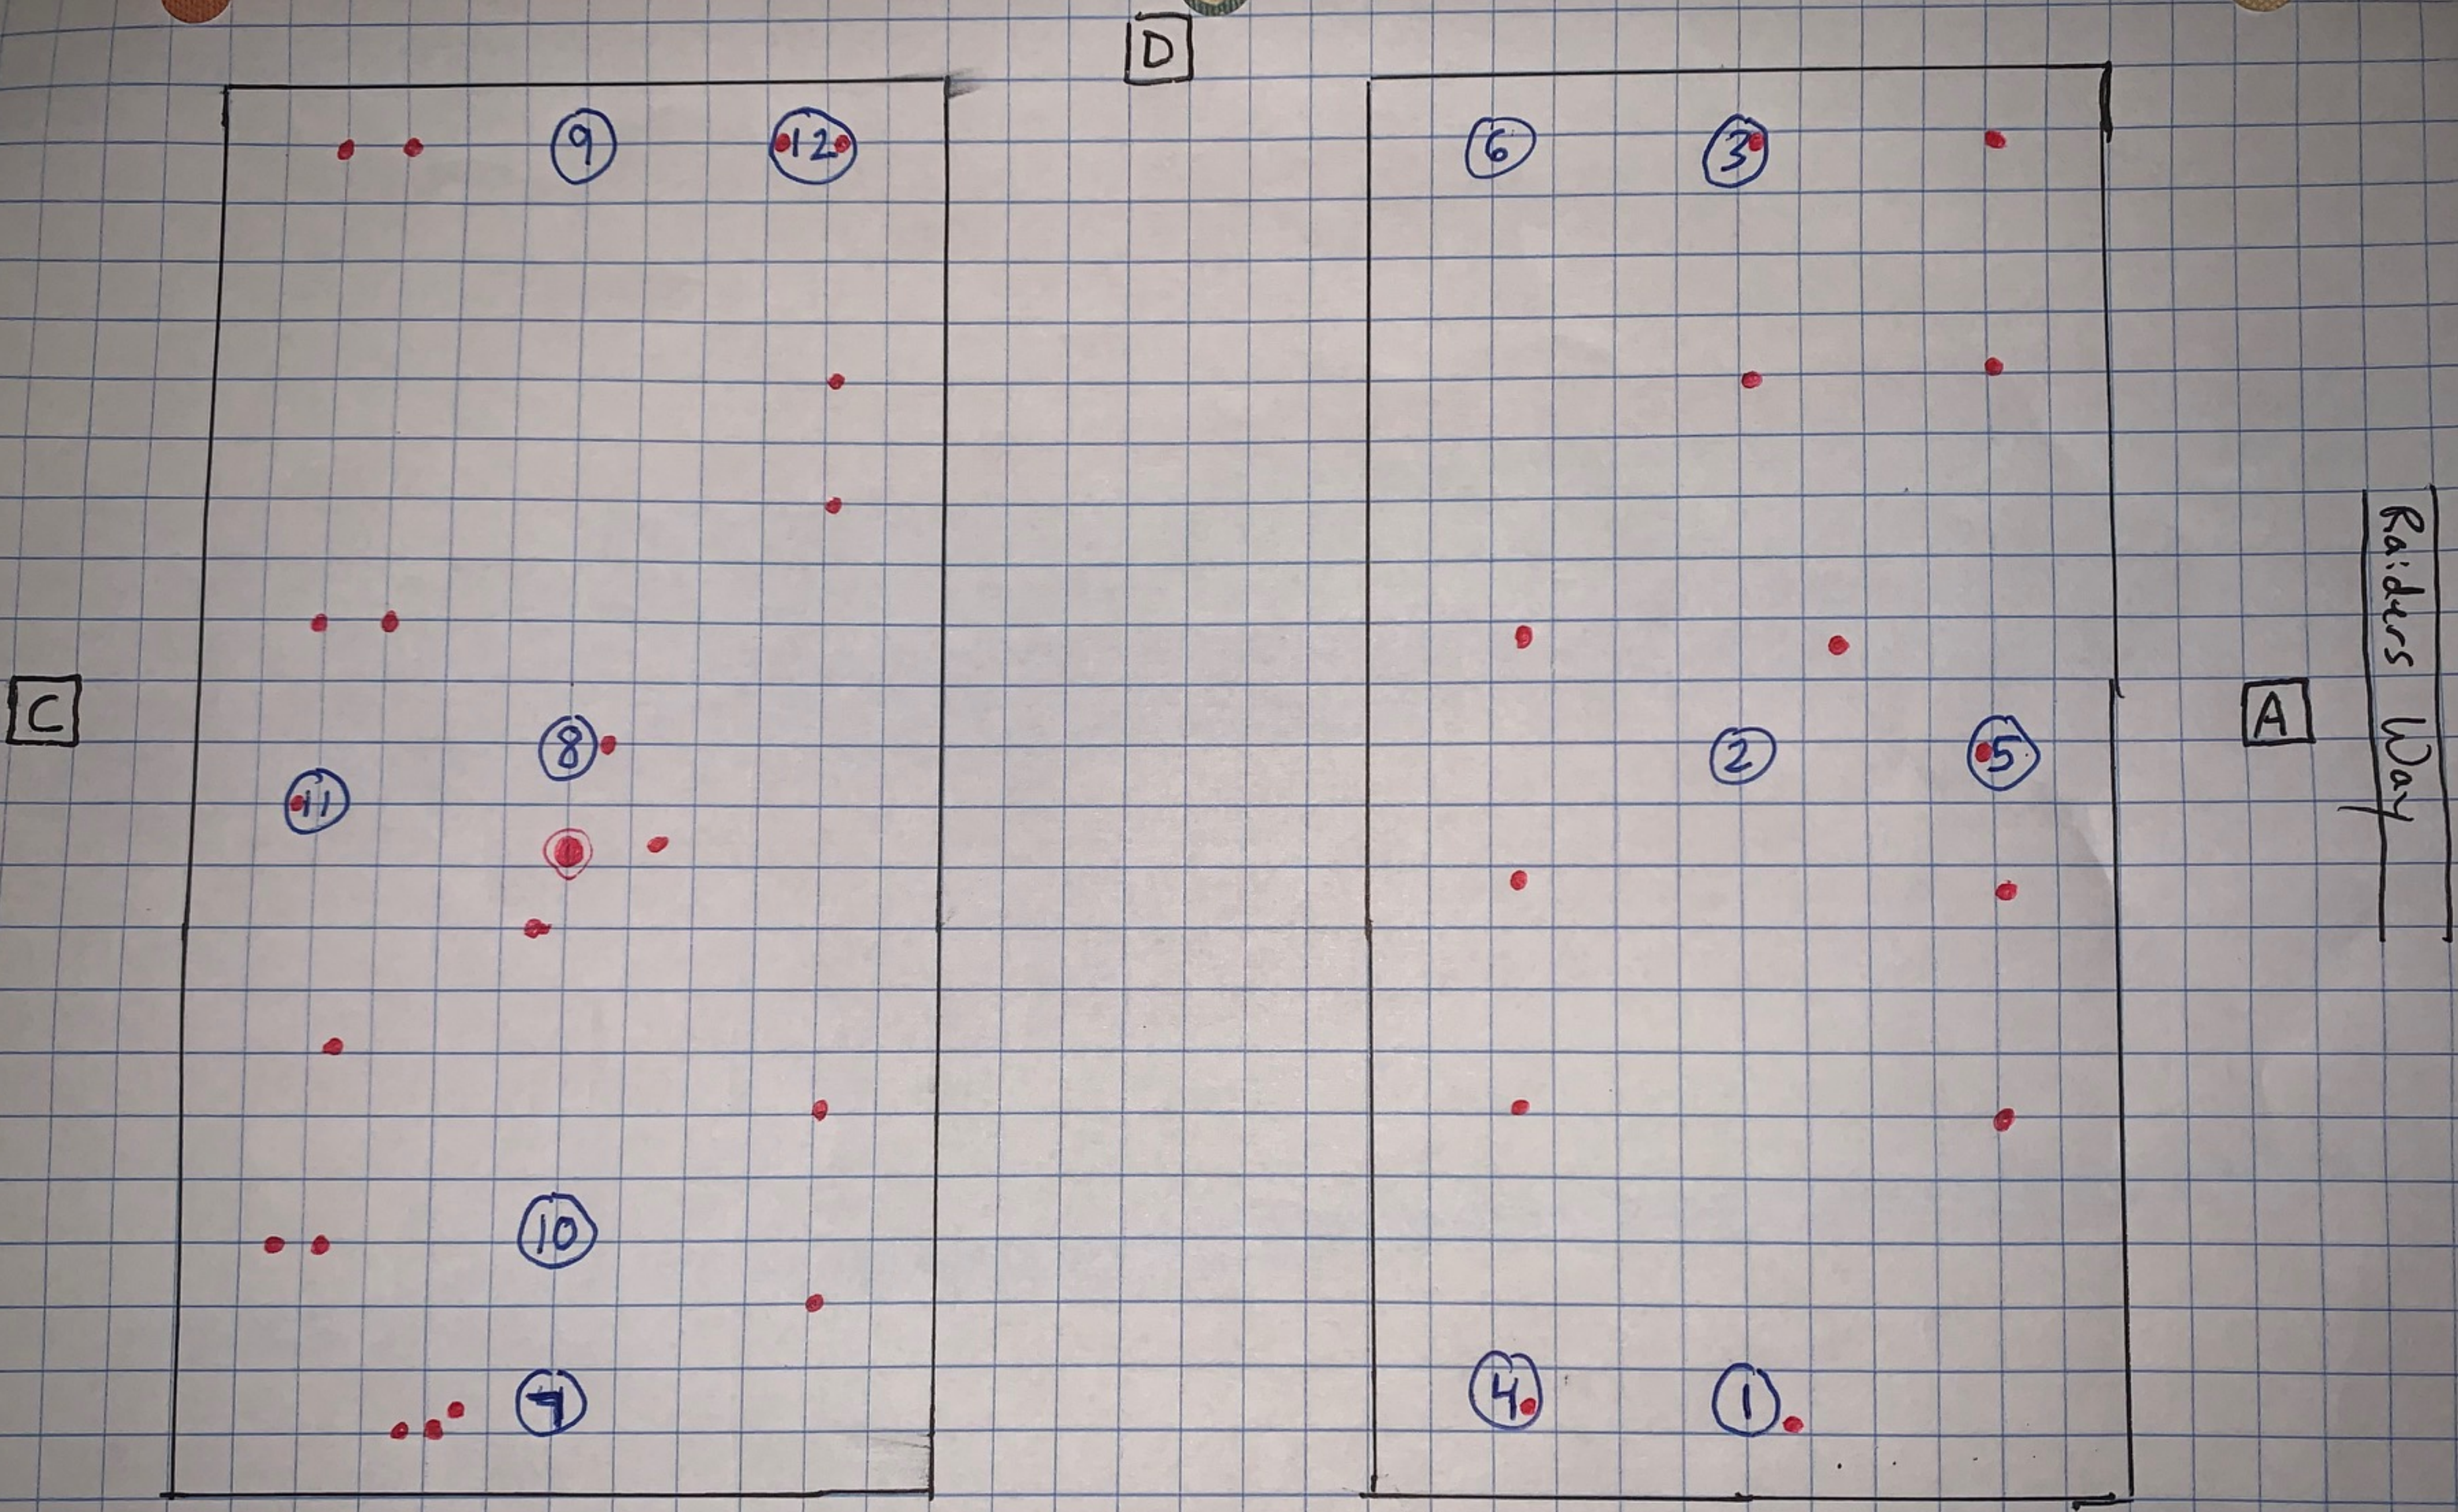
1400 Raiders Way Bldg. B+C

* PACM - 13 Transite pipes on Bldgs. B

* PACM - 21 Transite pipes on Bldgs. C

Transite pipe locations = ●
ASB. Sample locations = ⊕
